IMPORTANT SAFETY RECALL NOTICE

NHTSA Recall Number: 20V-456 School Bus NHTSA Recall Number: 20V-455 Non-School Bus

SUBJECT: R20AY – Steering Wheel Nut Torque Confirmation

R20AY – Steering Wheel Nut Torque Confirmation

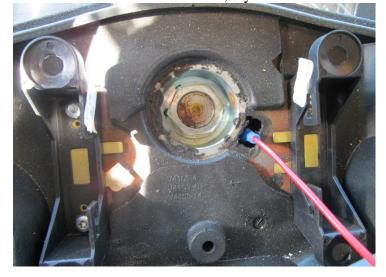
Photo 1

1. Lift up on top of steering wheel cover to remove. See Photo (1)

2. The cover contains the horn wire, lay the cover to the bottom.

- 3. Torque the steering wheel nut to 40-50ft lbs.
- 4. Ensure the horn wire is securely connected, then reinstall the steering wheel cover by pressing bottom portion in first followed by top of steering wheel cover until secure.
