Subject: Service Bulletin S14XG 8D Battery Cables Routing

Models Affected: 2010 through 2015 Model Year All American Front and Rear Engine

Battery Cable May Contact Battery Compartment Door Reinforcement

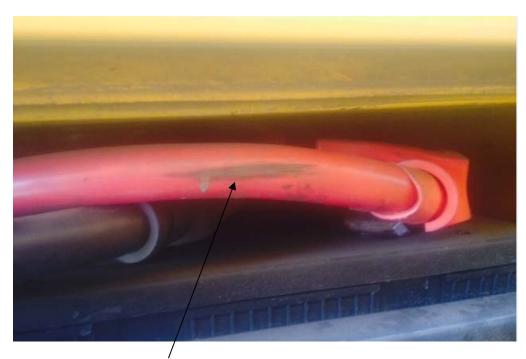
On buses with Feature 40142-04 8 D batteries, the positive battery cable may come in contact with the battery compartment door reinforcement when door is closed.

Indicates positive cable is contacting compartment door reinforcement

Inspect positive cable and, if needed, change routing of battery cables to insure proper clearance. Replace positive battery cable if damaged.

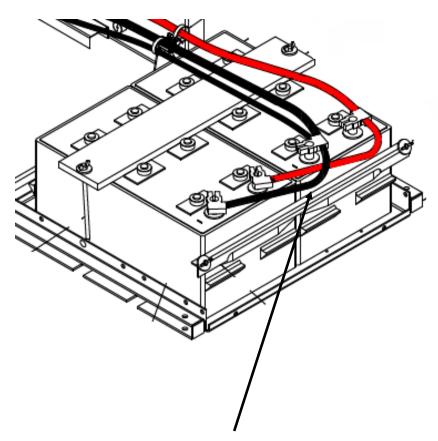
Negative Cable Routed Over Top of Positive Cable

- 3. If contact is observed, Disconnect batteries Note: when disconnecting the batteries, remove the negative cable first.
- 4. Inspect the positive cable for damage.
- 5. If cable insulation has been damaged to the point that stranded wires are exposed, replace the cable and route per the illustration below.
- 6. If cable insulation damage is minor and no stranded wire is exposed, route the negative cable so that it is over the positive cable per illustration below.
