**BLUE BIRD**

**S20AT**

**Subject:** S20AT, Dual Fuse Block Assembly Inspection

## S20AT - Dual Fuse Block 10041668 Assembled Incorrectly

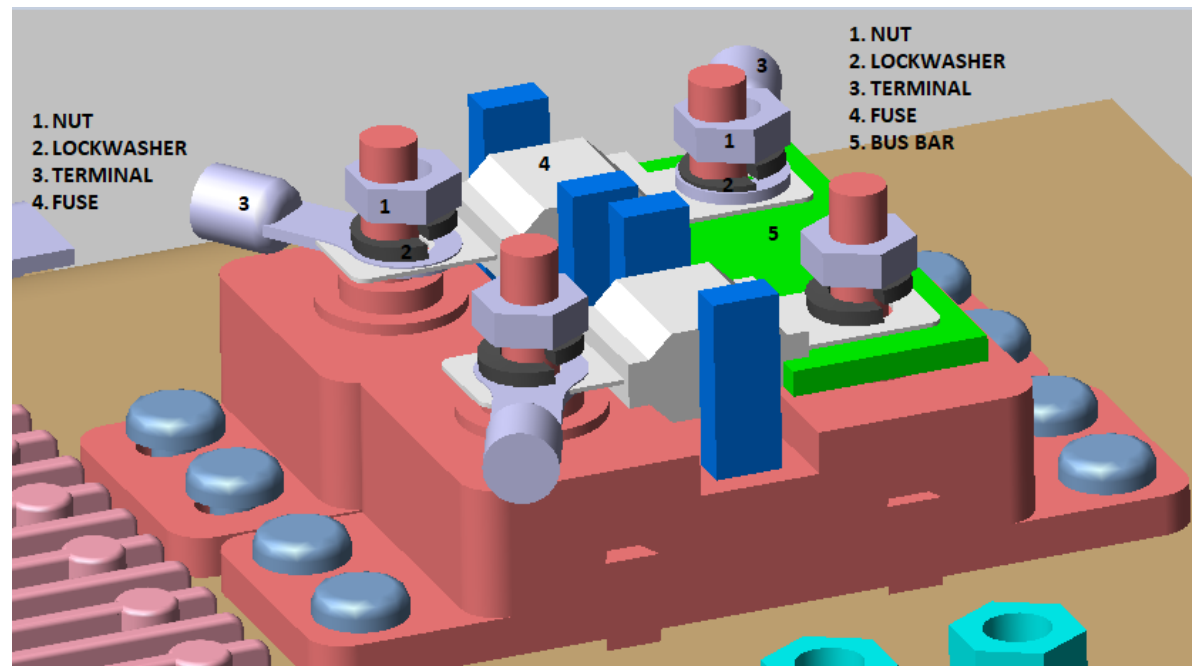
**Issue:** Certain Buses built with Feature 40076-04 may have dual fuse block 10041668 assembled incorrectly, causing the ABS fault lamp to illuminate.

2. First inspect and verify that the Lock Washer (Item 2) is positioned under the nut (Item 1), then verify the fuses and power wires to the dual fuse block are properly oriented and secured (See Figure 1 and 2 below). Verify the nuts on fuse block are tight. Verify wires are not loose. \*NOTE- Terminal (Item 3) should be on TOP of the fuse. See Figure 1 for proper alignment.

3. If lock washers are properly aligned, but nuts are loose, tighten nuts to 3-5 N-m (26-44 inch-lbs.). If lock washer is not beneath the nut, disconnect battery power (required) and reassemble per Figure 1. Be sure the wires to the fuses are connected, as shown in Figure 2.
